## Operation No. 23 Windshield Glass, Reveal Molding, and Sealing Channel

## WINDSHIELD

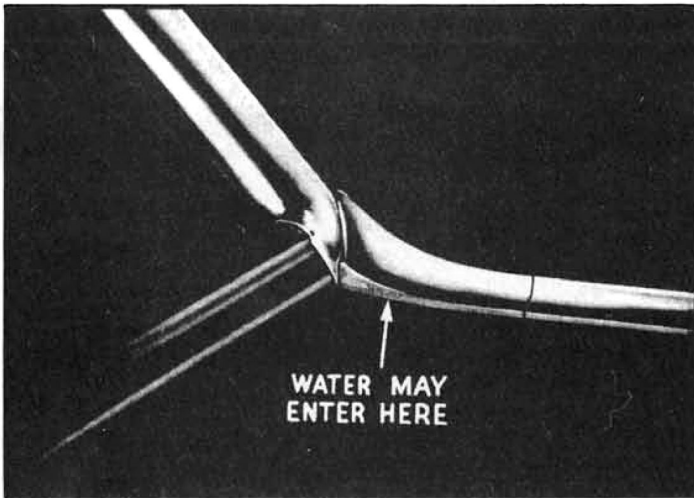
On some 1946 body styles, a water leak may develop at the base of the cowl top molding as shown. If water-tests show a leak at this point, loosen the retaining stud bolt (underneath the cowl) and remove the assembly.

Clean all contacting surfaces with carbon-tetrachloride or clear gasoline (not ethyl) to remove dirt and old cement. After parts are thoroughly dry, apply a coating of "3-M Weatherstrip Cement" to contacting surfaces of cowl and gasket as shown by arrows 1 and 2 and fill chrome cap with "3-M Autobody Sealer" as indicated by arrow at 3. Permit cement to dry "tacky" (about ten minutes) before re-installing the molding. Wipe away all surplus cement sealer.

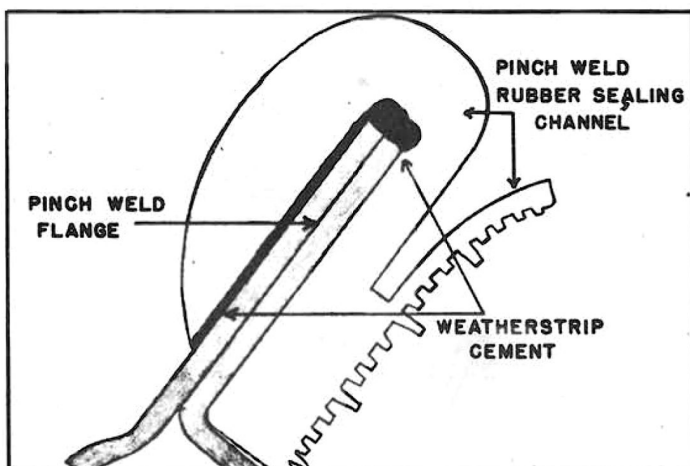
Cross section showing the installation of the pinch-weld sealing channel around windshield opening. A heavy bead of "3-M Weatherstrip Cement", as shown by the shaded area, is applied under the sealing lip around this channel before it is installed. Lack of cement, in areas shown, may cause water to work its way under lip of rubber sealing channel and down through pinch weld.

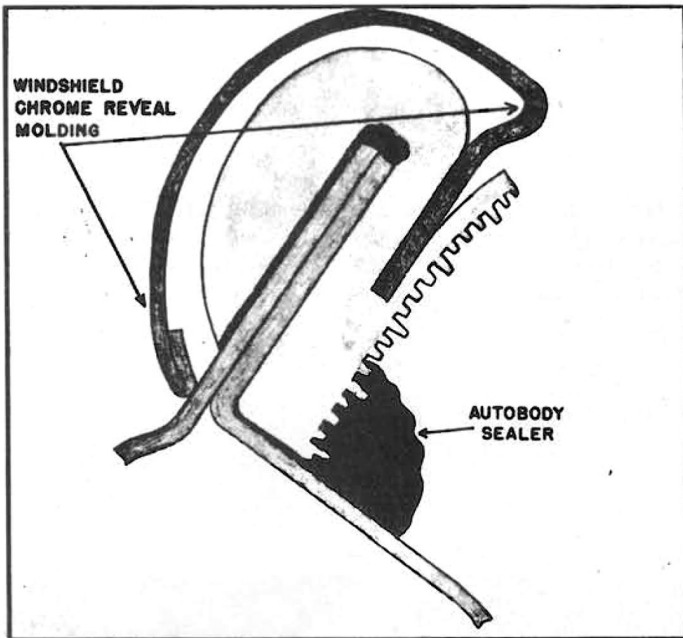
2

Next, the windshield chrome reveal molding is installed and then, prior to windshield installation, a heavy bead of "3-M Autobody Sealer" is applied clear around the opening at the area as shown.

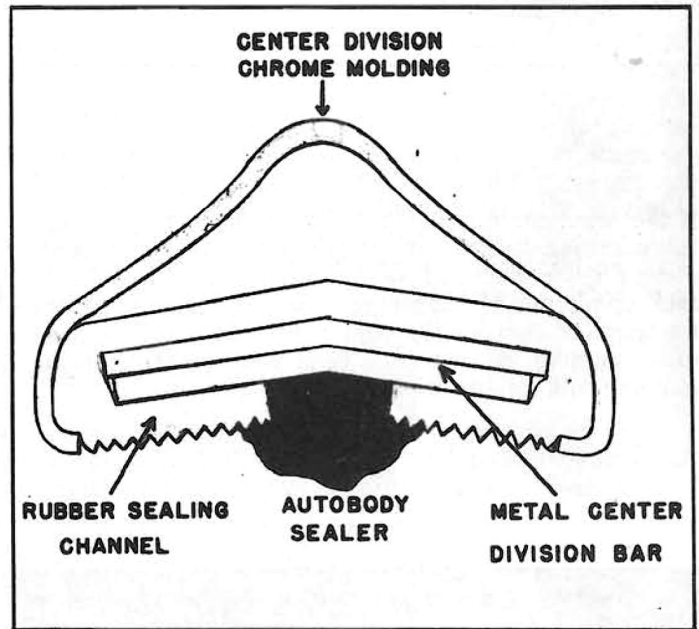
3

Cross section of windshield center division bar, showing "wrap around" portion of pinch weld sealing channel and windshield outer division chrome molding. Prior to windshield installation, a heavy bead of "3-M Autobody Sealer" is applied the full length of the rubber channel at the area as indicated.

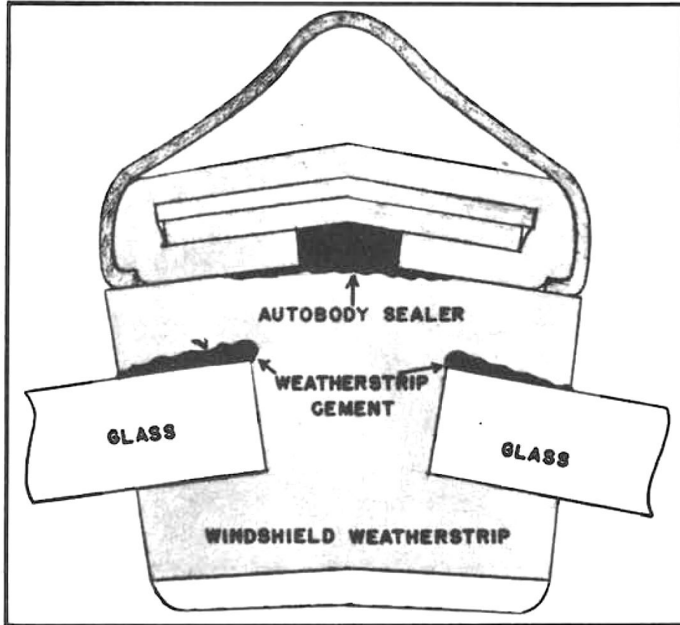
**5** Center division section of windshield after windshield glass and weatherstrip has been installed. Note how "Autobody Sealer" has levelled off to affect a proper seal.

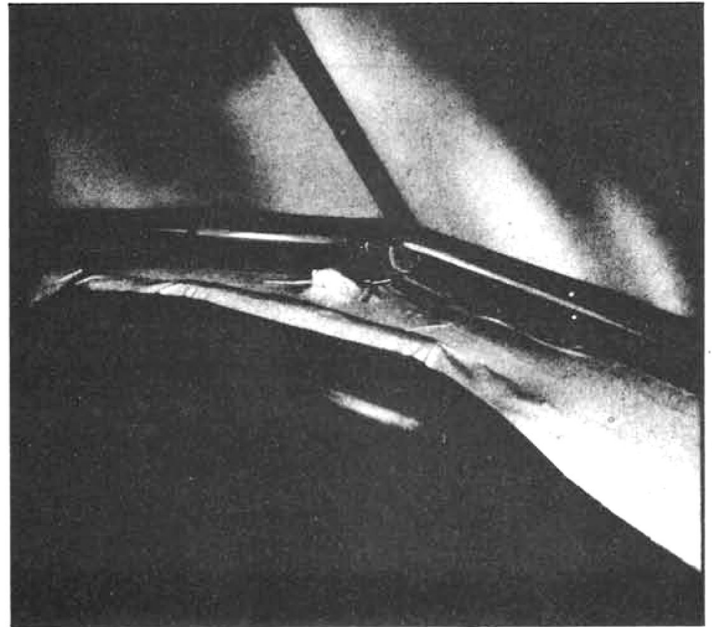
**6**

If the windshield leak is chronic, it is best to remove either half or all of the windshield and completely re-embed and seal it in its opening. Begin this operation by applying masking tape along the top edge of instrument panel, adjacent to the garnish molding as shown. Then remove the garnish molding and center division molding.

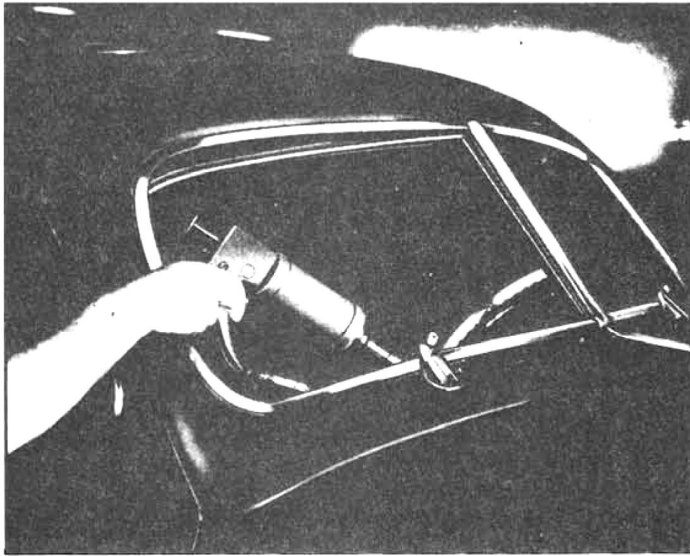
8

With a sealing gun lay a bead of "3-M Autobody Sealer" around the inside edge of the windshield opening as shown. Next, cement the lip of the windshield rubber weatherstrip to the glass using a sealing gun and "3-M Weatherstrip Cement".

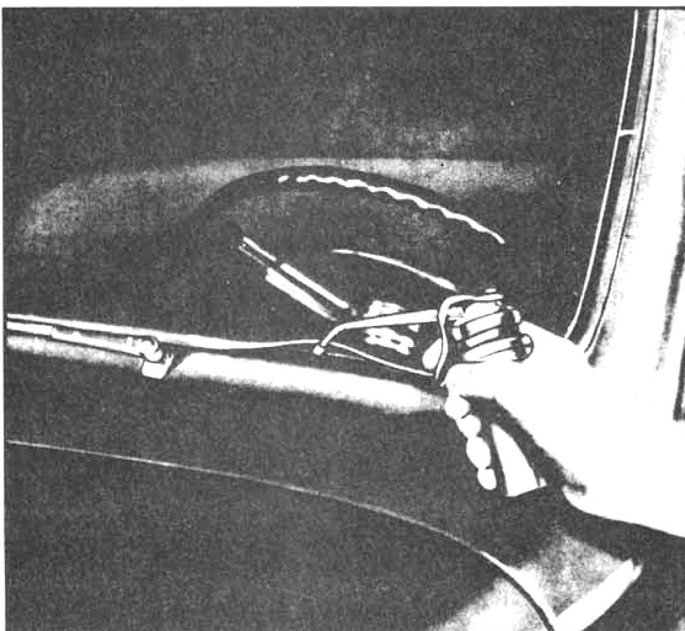
10

On Chevrolet Stylemaster bodies which have no windshield reveal molding, simply insert the nozzle of the sealing gun under the lip of the outer rubber weatherstrip and place a bead of "Weatherstrip Cement" around the entire windshield opening.
