## Operation No. 23 Windshield Glass, Reveal Molding, and Sealing Channel

## WINDSHIELD

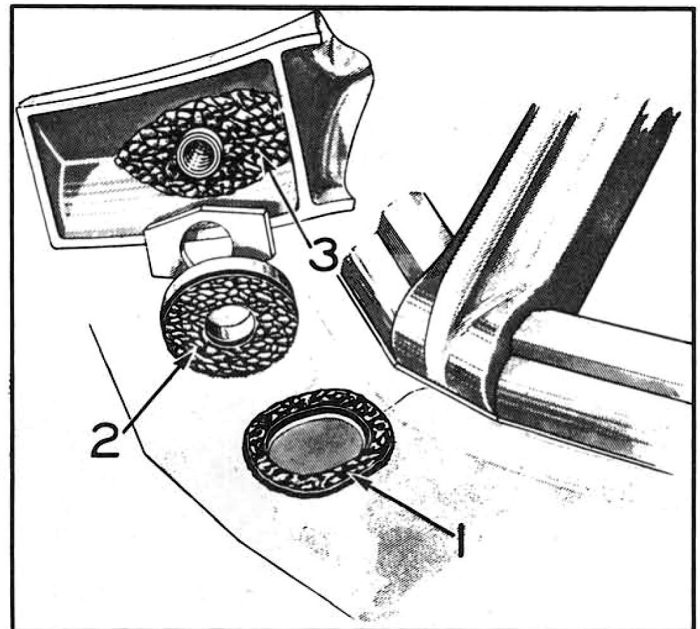
On some 1946 body styles, a water leak may develop at the base of the cowl top molding as shown. If water-tests show a leak at this point, loosen the retaining stud bolt (underneath the cowl) and remove the assembly.

Clean all contacting surfaces with carbon-tetrachloride or clear gasoline (not ethyl) to remove dirt and old cement. After parts are thoroughly dry, apply a coating of "3-M Weatherstrip Cement" to contacting surfaces of cowl and gasket as shown by arrows 1 and 2 and fill chrome cap with "3-M Autobody Sealer" as indicated by arrow at 3. Permit cement to dry "tacky" (about ten minutes) before re-installing the molding. Wipe away all surplus cement sealer.

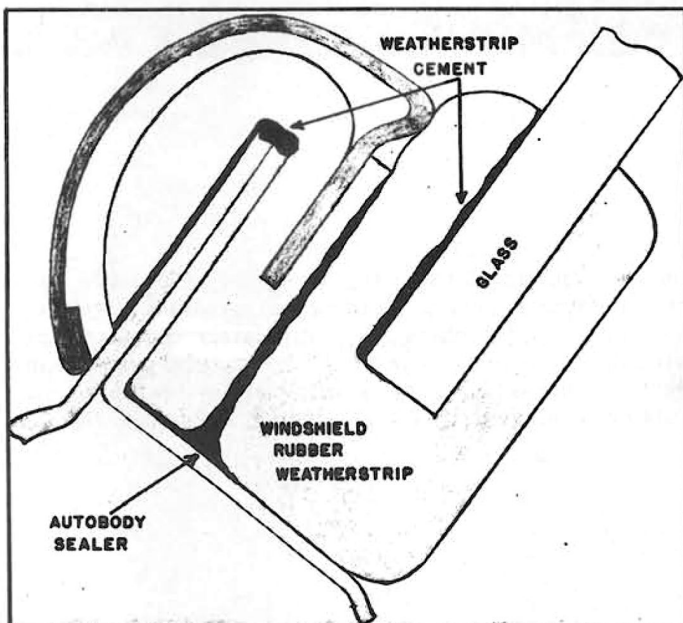
1

Cross section showing the installation of the pinch-weld sealing channel around windshield opening. A heavy bead of "3-M Weatherstrip Cement", as shown by the shaded area, is applied under the sealing lip around this channel before it is installed. Lack of cement, in areas shown, may cause water to work its way under lip of rubber sealing channel and down through pinch weld.
